Burners

Purpose:

To alert customers to known mechanical problems with burners and to provide recommendations for corrective action.

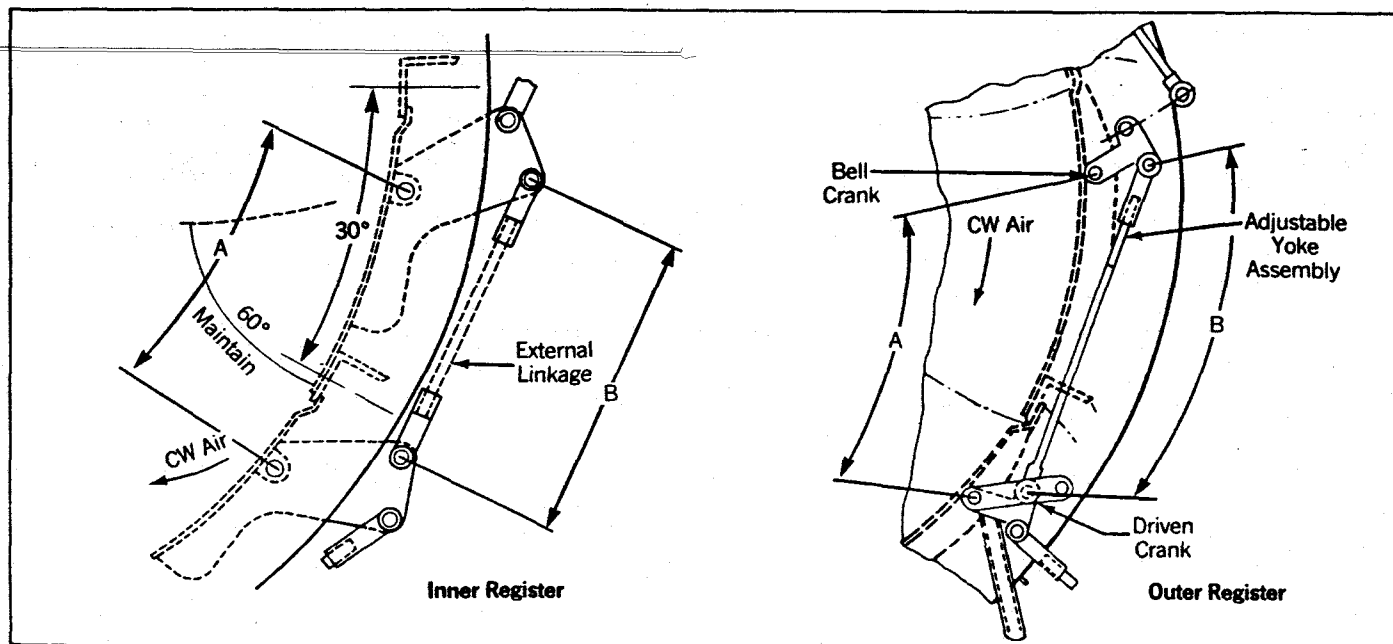
Figure 1 Inner and outer registers.

Register doors bind on
Dual Register Burners.

Linkage is improperly
adjusted.

Adjust register door linkage as follows:
Adjust length of linkage (Figure 1) so that distance, center to center, between pins is equal to distance, center to center, of door shafts on linkage (distance A is equal to distance B). Distance between door shafts may vary with different blades.

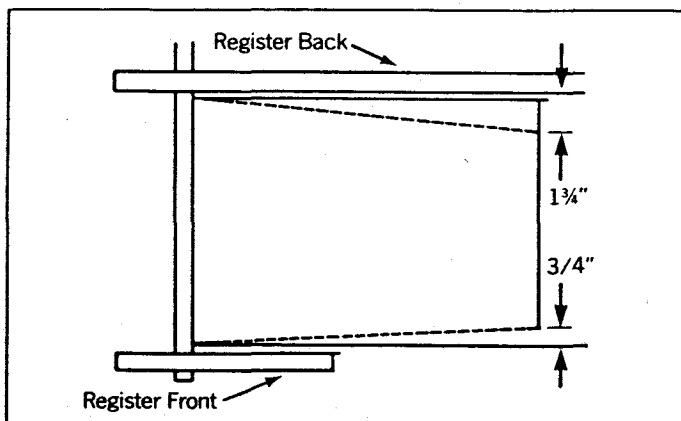
Figure 2 Typical register blade.

Front plate and/or back plate
warping.

1. Trim register blade to clear front and/or back plate (Figure 2). Install thermocouples to set minimum cooling air.
2. Upgrade registers with H.D. register assembly for better reliability (Figure 3). An engineering review is recommended when a major modification is considered.

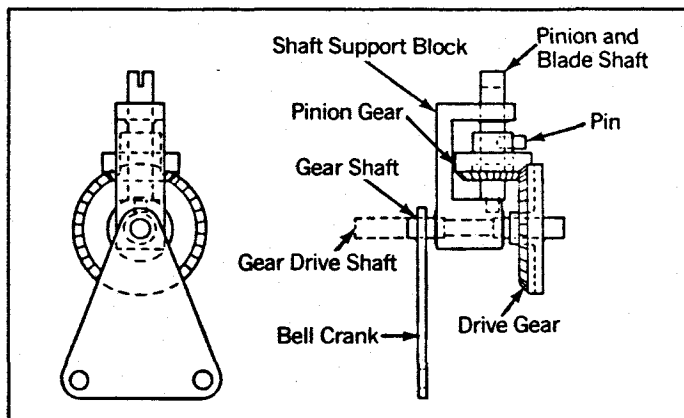
Figure 4 Coarser gear.

Spin vanes bind on Dual Register Burners

Ash is adhering to gear teeth.

1. Replace existing spin vane drive gears with new (coarse) design (Figure 4). This will minimize fly ash problem.
2. Do *not* use oil base lubricants on gears or register linkages. A graphite base lubricant is recommended, and only when necessary.

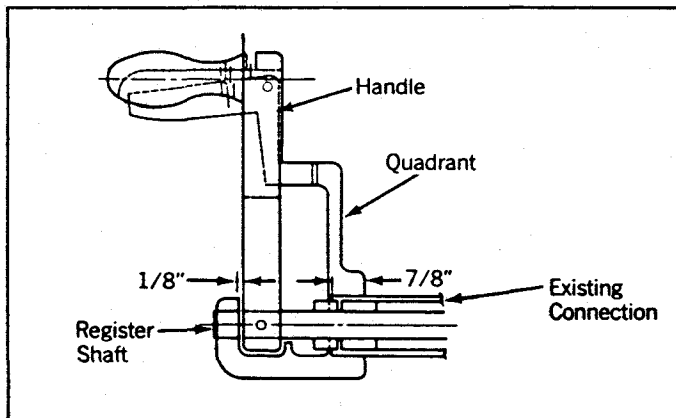
Figure 5 New quadrant.

Register position reference lost.

Quadrant unscrews from threaded connection on windbox.

Replace aluminum quadrant with cast steel quadrant (Figure 5). The cast steel quadrant slips over existing threads. Set register position reference and weld new quadrant to threaded wind box connection after matching actual register position with quadrant position.

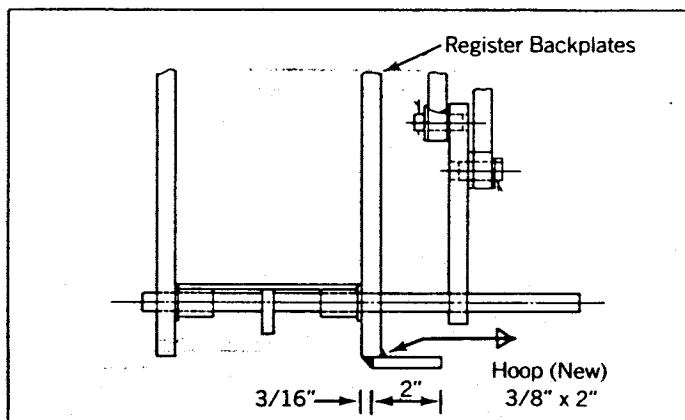
Figure 6 Typical repair for burner backplates.

Burner backplate overheats, distorts and warps.

When burners are out of service, cooling air may be insufficient to cool burner backplates

1. Straighten backplate and add a hoop to reinforce it (Figure 6).
2. Install permanent thermocouples on register and burner to determine if cooling air to out of service burner is adequate (Figure 7). Monitor thermocouples and adjust cooling air by using compartment dampers to keep burner cool.

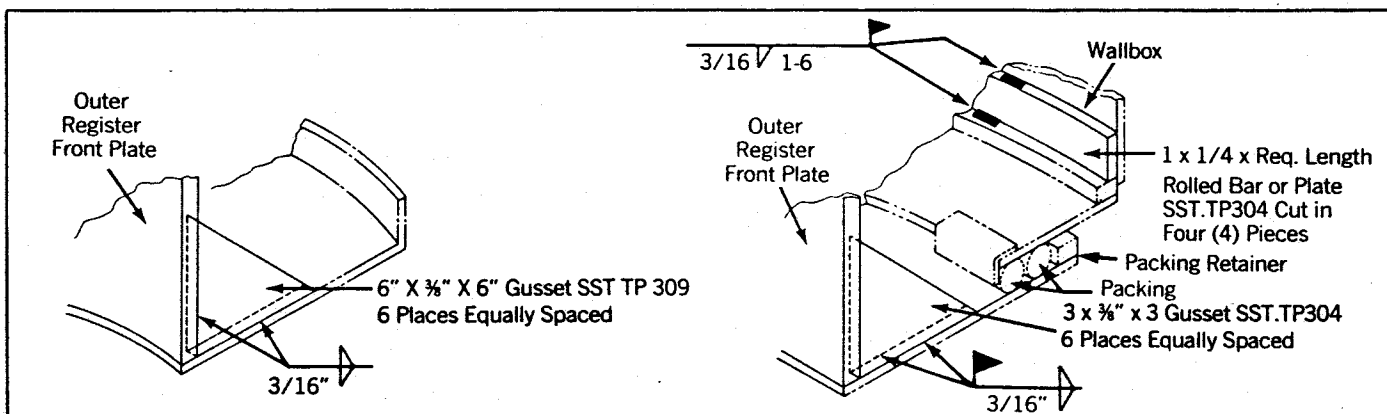
Figure 8 Slip seal plate modification (see Figure 7 for Location).

Air bypasses burner register assembly.

Register assembly warps. Front wall seal plate connection fills with debris and does not allow proper expansion movement.

Trim seal plate and add several rows of packing and a packing retained plate (Figure 8). Fiberfrax 2300 is recommended for packing. It retains its tensile strength while hot.
